FIELD INVESTIGATION
of
ATLAS ASBESTOS
and
COALINGA ASBESTOS MINES

Date of Investigation: May 19 to 21, 1980

This is an ~~in-progress~~ report of asbestos contamination of streams in the Atlas Mine and Coalinga Mine areas. It is based on a field inspection of the area conducted on May 19 to May 21, 1980. This report contains the results of laboratory analysis which were available as of July 22, 1980.

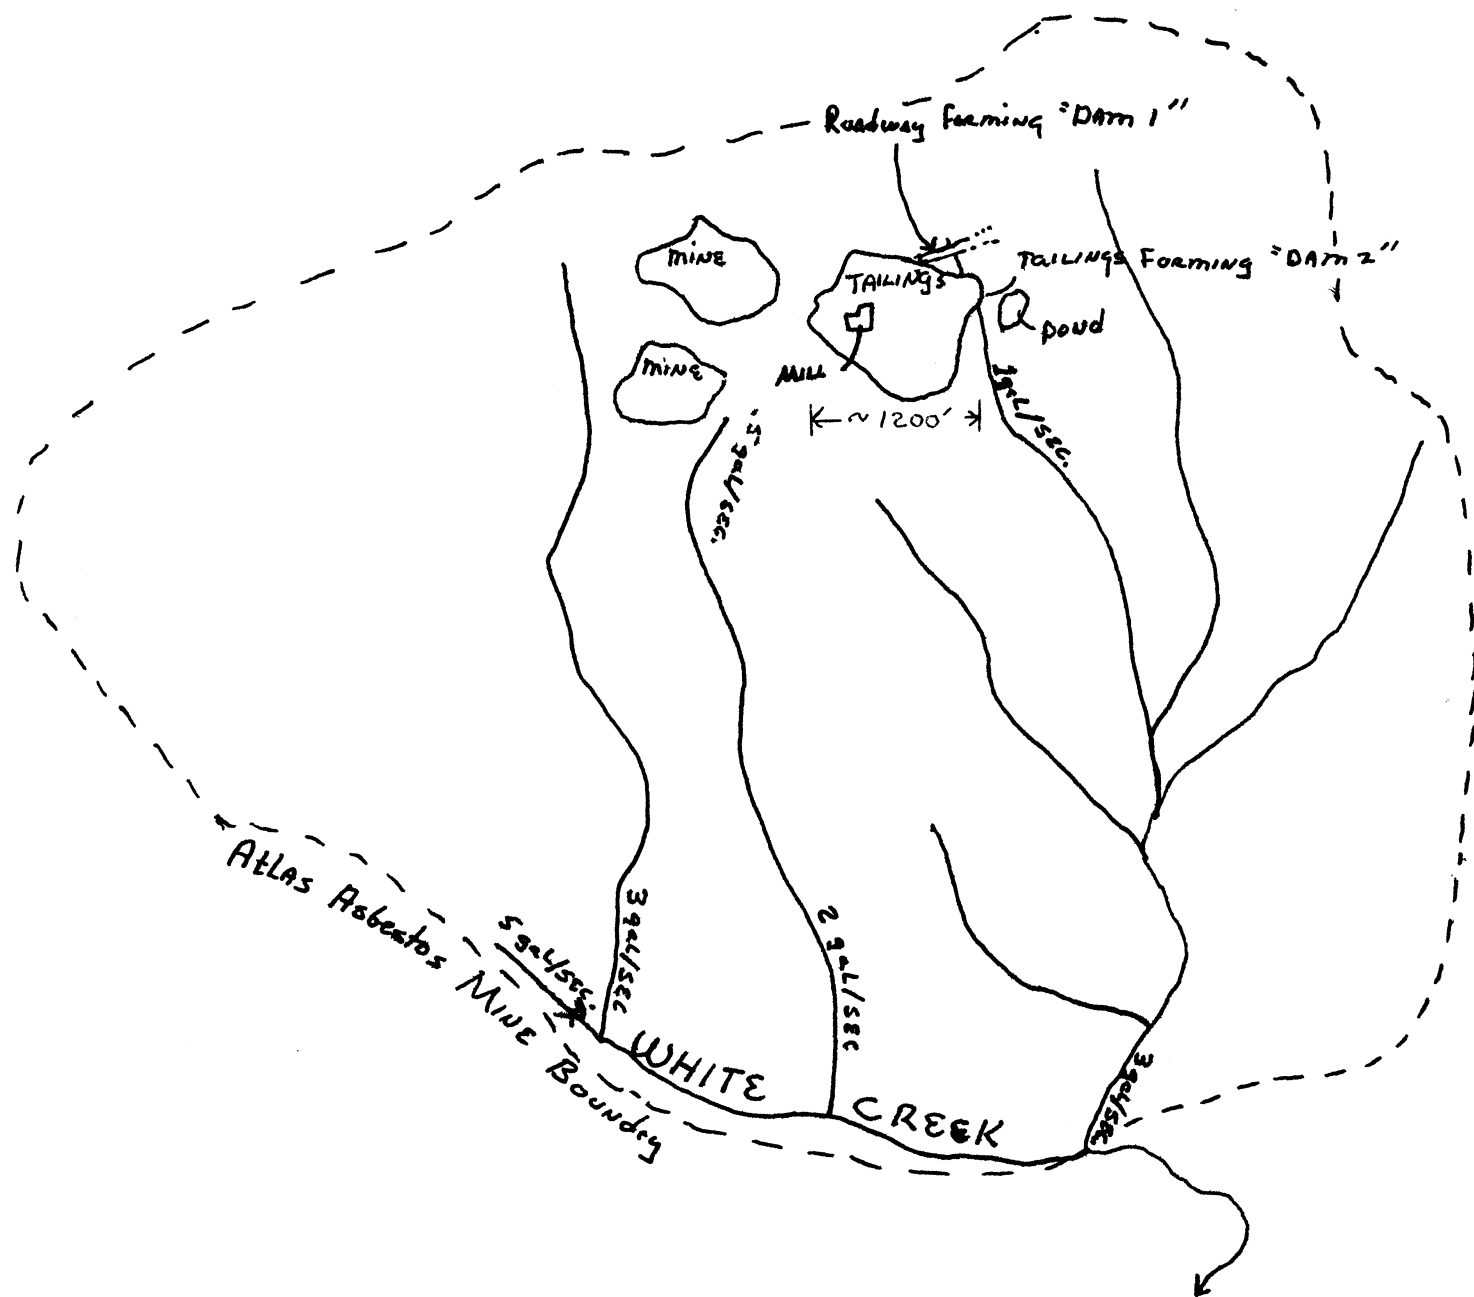
MAP 6

Map 6 gives dimensions and major features of the tailings area. The tailings pile was estimated to be 20 acres in area. Analysis of field samples (See Sampling section) indicated the tailing pile was 10% (by weight) chrysotile, a fibrous asbestos mineral. Photos A 7 through A 10 are a panoramic view of the plateau of the tailings pile. Note the fine, non-crusted surface texture of the tailings. Photos A 11 to A 15 show clear evidence of the extensive erosion of the tailings pile.

Map 6 also indicates the erosion control structures associated with the tailings pile. Dam A is approximately 15 feet thick, 20 feet high and 75 feet long. It is not apparent if its purpose is to impound water from above the tailings or to provide a road crossing across the canyon. This dam was constructed of crushed rock. "Dam" B is merely an extension of the tailings pile across a stream channel. (See photo A 16 and A 17.) This "dam" has been breached. It is not capable of impounding a significant amount of runoff. It does contribute a sizeable amount of eroded asbestos-bearing material to the stream.

An erosion control program should be implemented to reduce erosion of the tailings piles and thus reducing the amount of asbestos entering local streams.

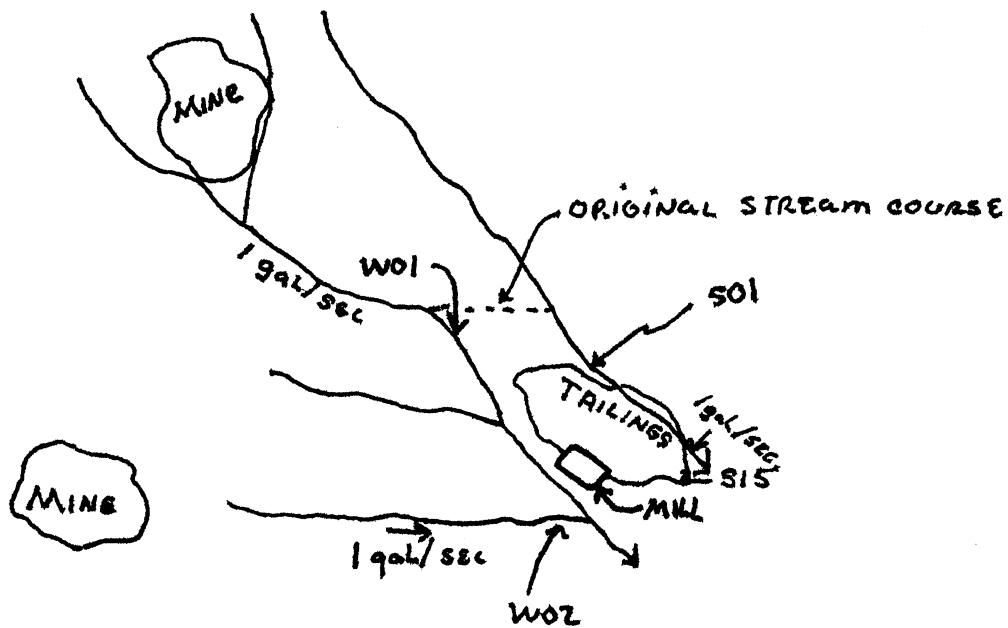
MAP 7

The location of the tailings pile in a natural drainage canyon can lead to extensive tailings erosion if erosion control structures are not utilized. Two major erosion control structures were observed. First, as indicated on map 7, an unnamed stream has been diverted from the tailings pile. The diverted stream completely bypasses the tailings. The second major erosion structure was a series of small dams located on the top and also downstream of the tailings pile (see photo C 10 and C 11.) Erosion of these dams has occurred. The area surrounding the overflow pipes has been eroded to the point where each dam's capacity has been severely decreased. The furthest downstream dam observed was badly breached (see photo C 13). This series of dams, in their present condition has limited erosion prevention capability. Significant erosion of tailings material directly into an unnamed tributary of Pine Canyon Creek does occur.

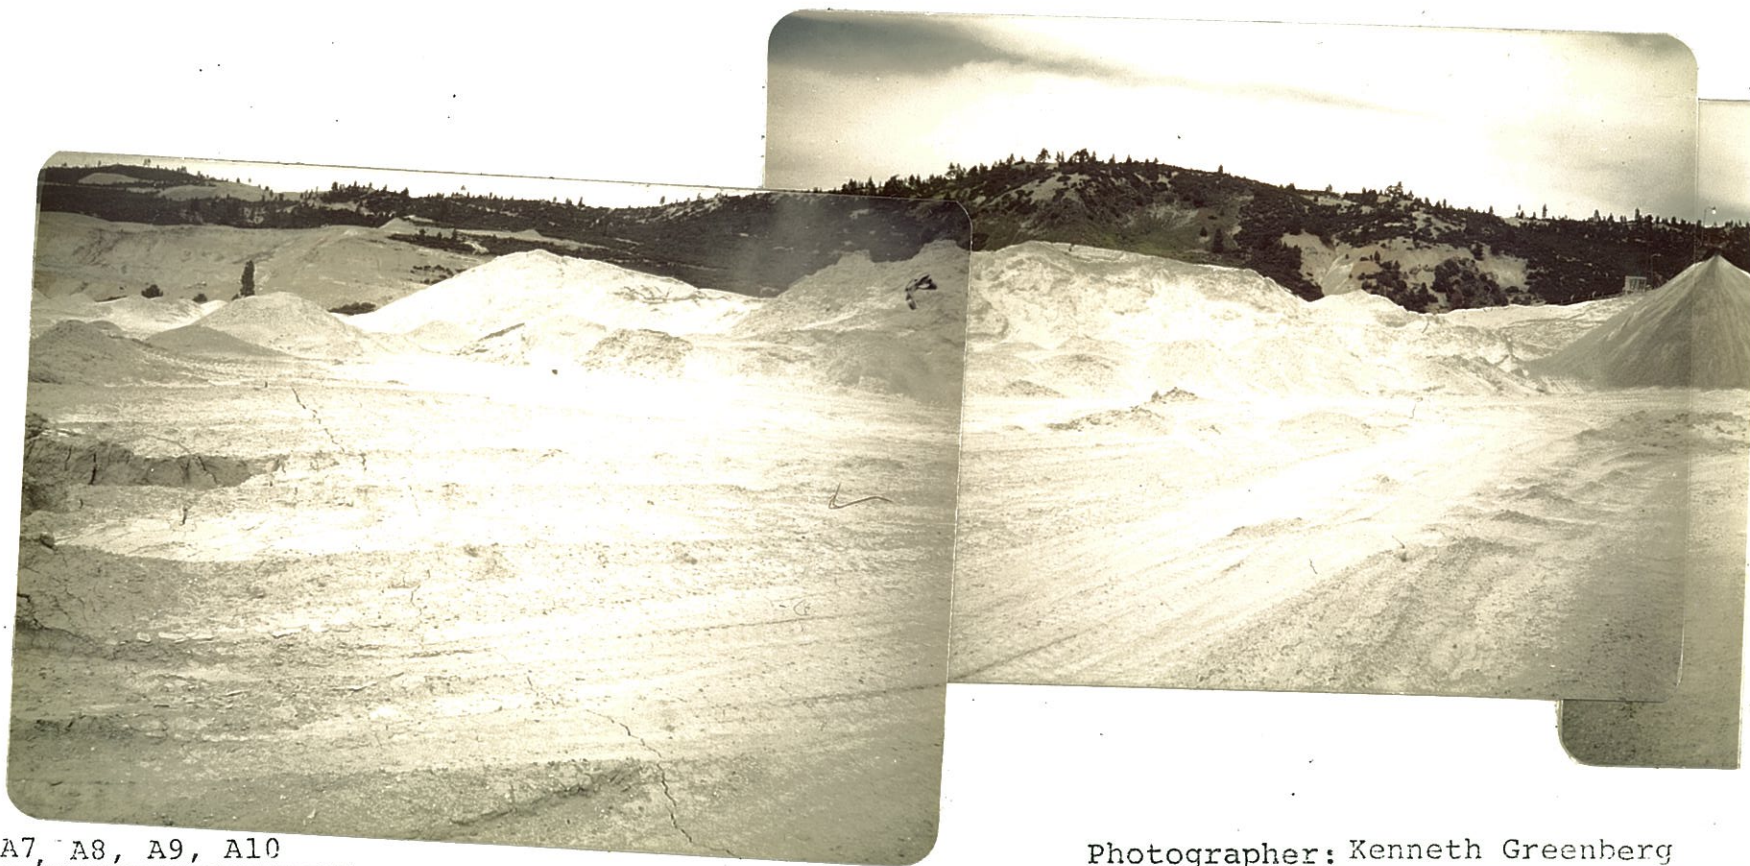
No. A7, A8, A9, A10

Subject: Tailings pile at the Atlas Asbestos Mine.

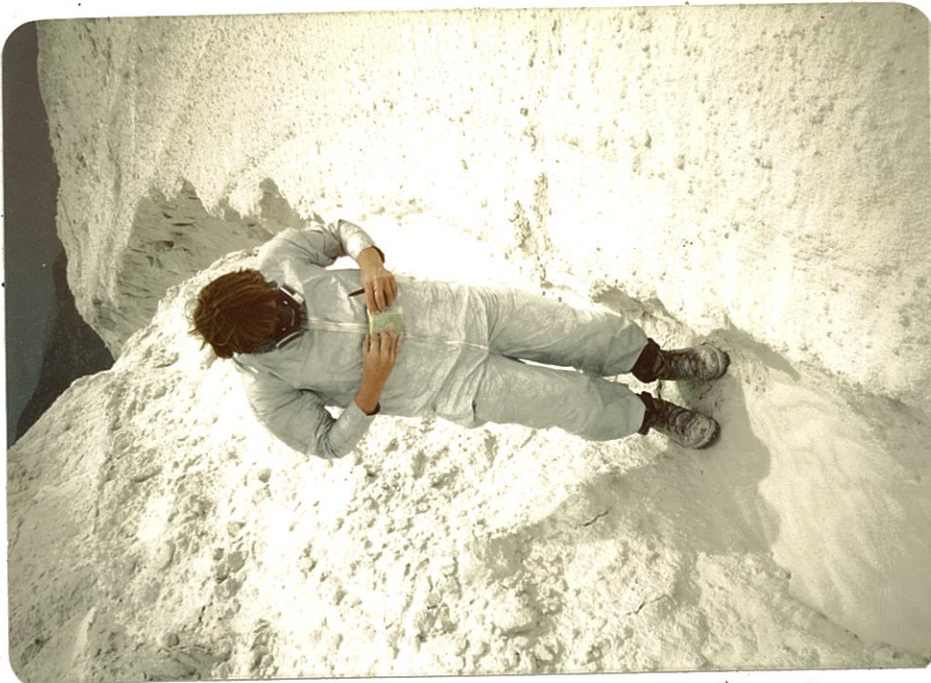
No. A13 Subject: Atlas Asbestos Tailings pile.
Site where sample S06 was collected.

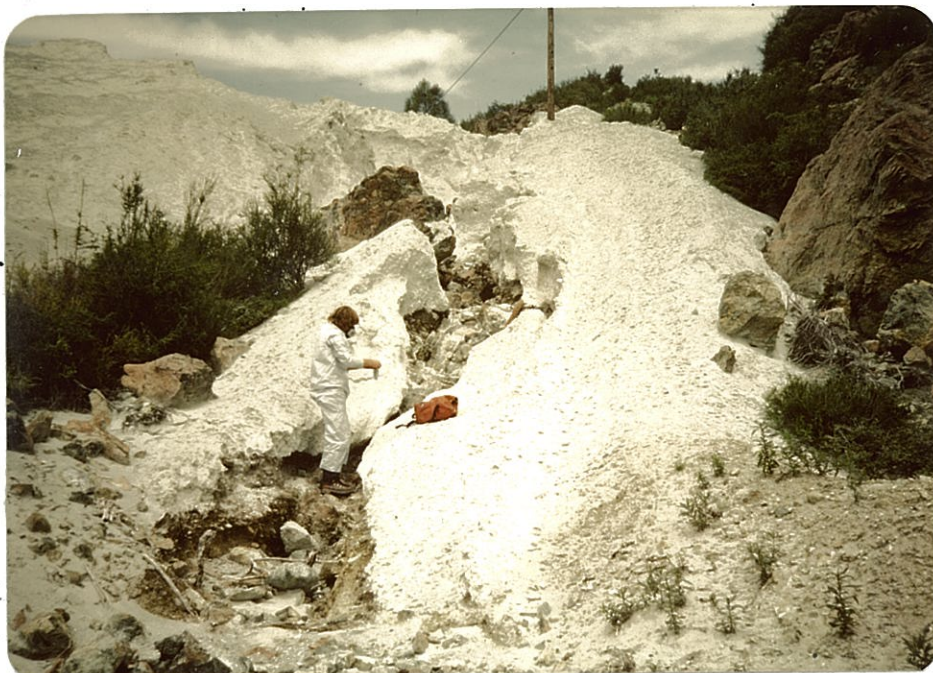
No. A15 Subject: Atlas Asbestos Tailings Pile.
Sample S03 was collected at this site. NOTE: The
tailing in the background is blocking the stream channel.
Facility: Atlas Asbestos Mine

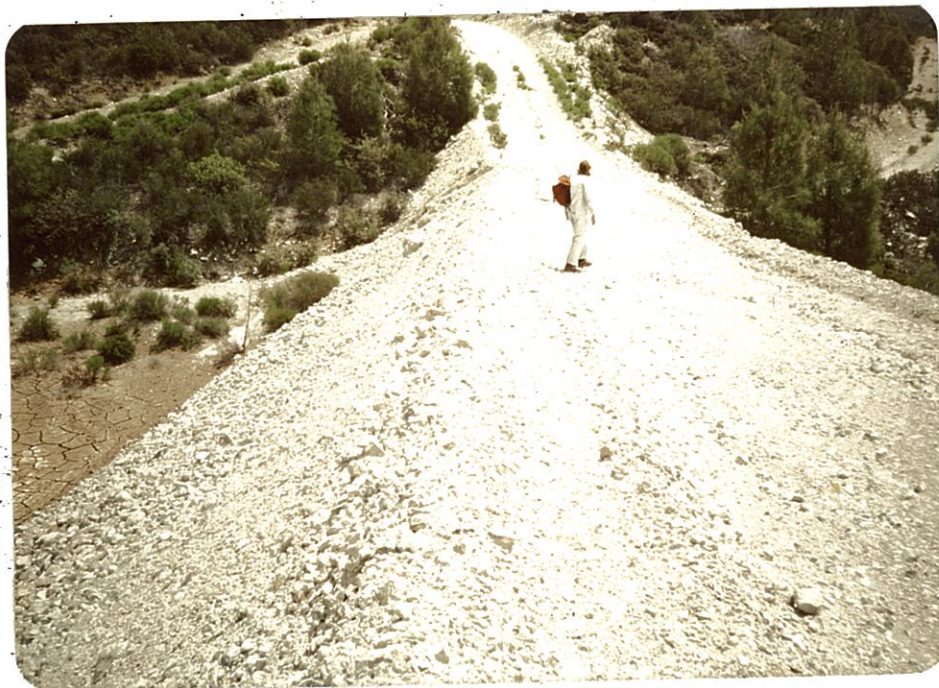
No. A16 Subject: Dam near tailing pile.

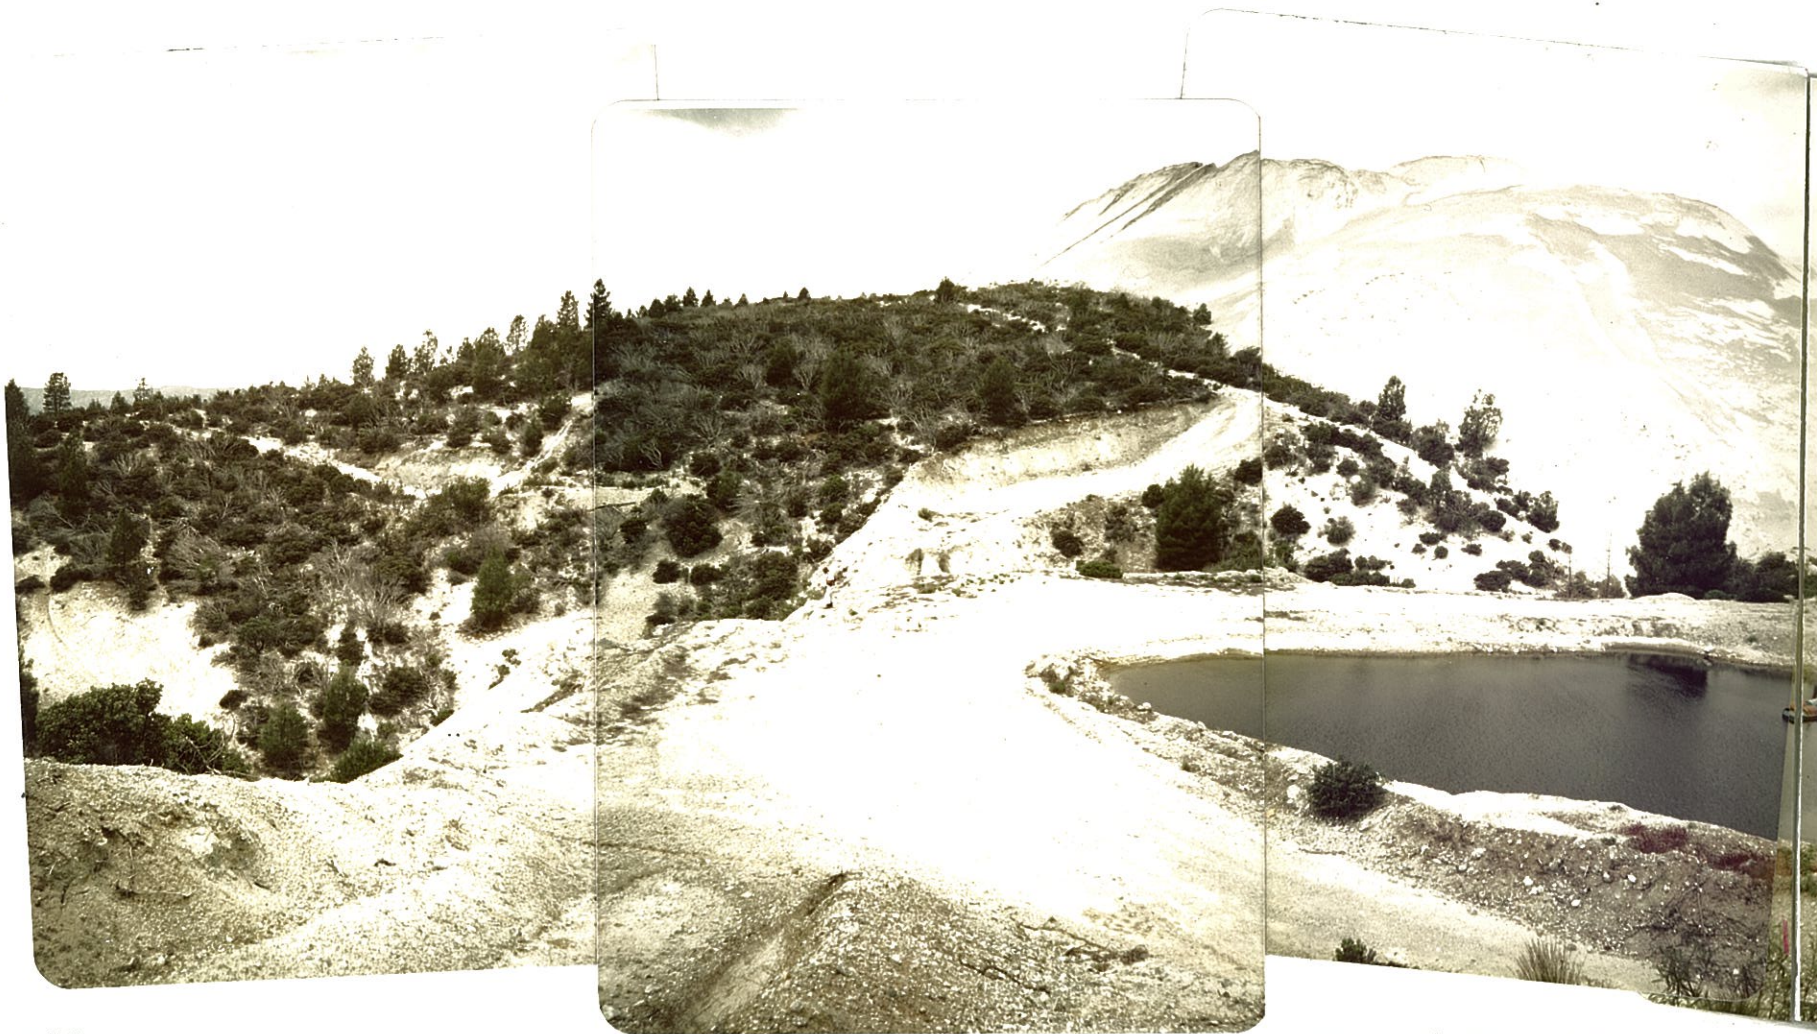
No. A17, A18, A19, A20

Pond A impounds water from a limited watershed to the northeast of the tailings pile. Part of this water is utilized as process water by the mill. The pond is approximately 100 feet in diameter and had 5 feet of freeboard at the time of inspection. (See photos A 17 to A 20.)

Subject: East side of tailings pile

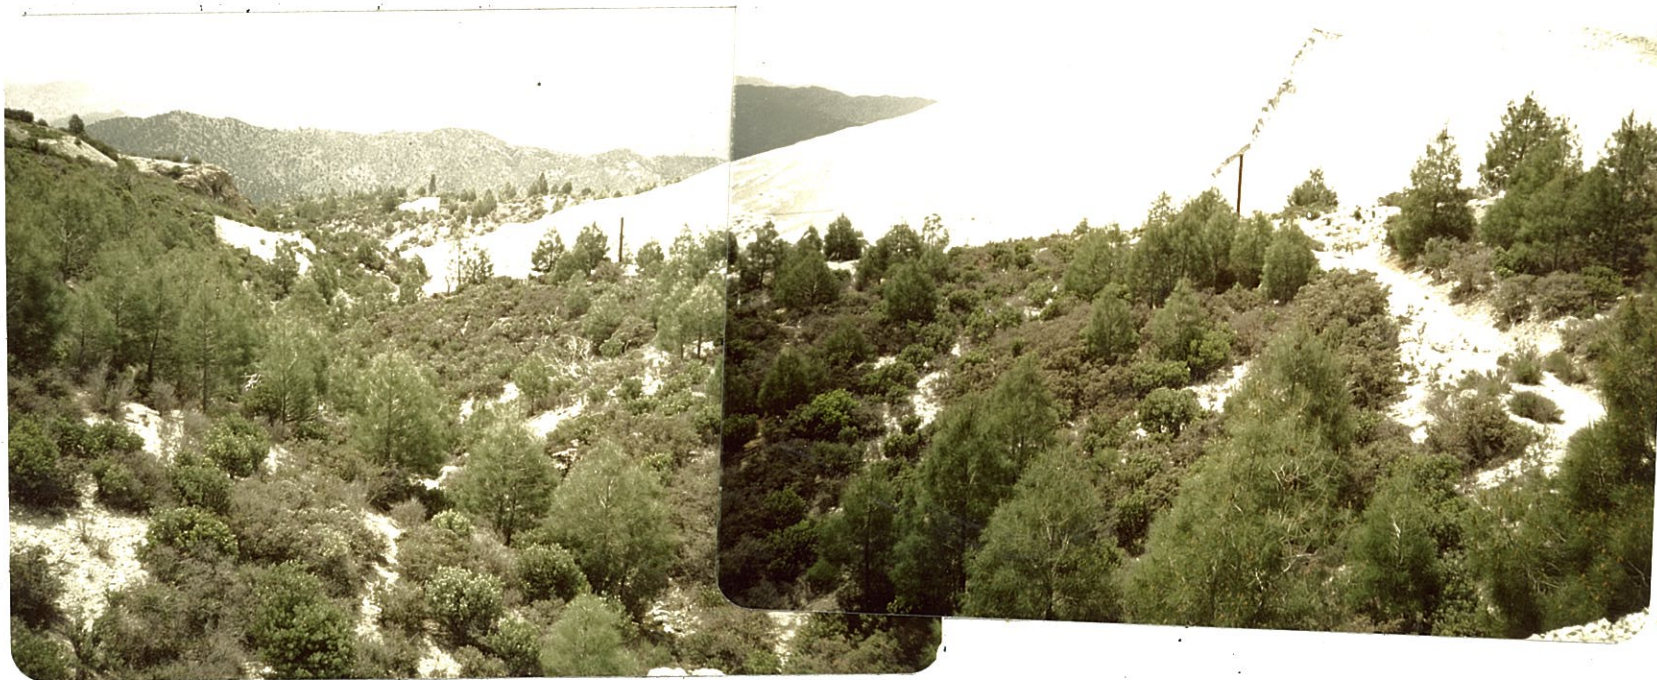
No. A21, A22

Subject: Atlas Asbestos Tailings Pile. This picture was taken
from "Dam 4" looking south. Note the tailings material extending
across the stream channel.

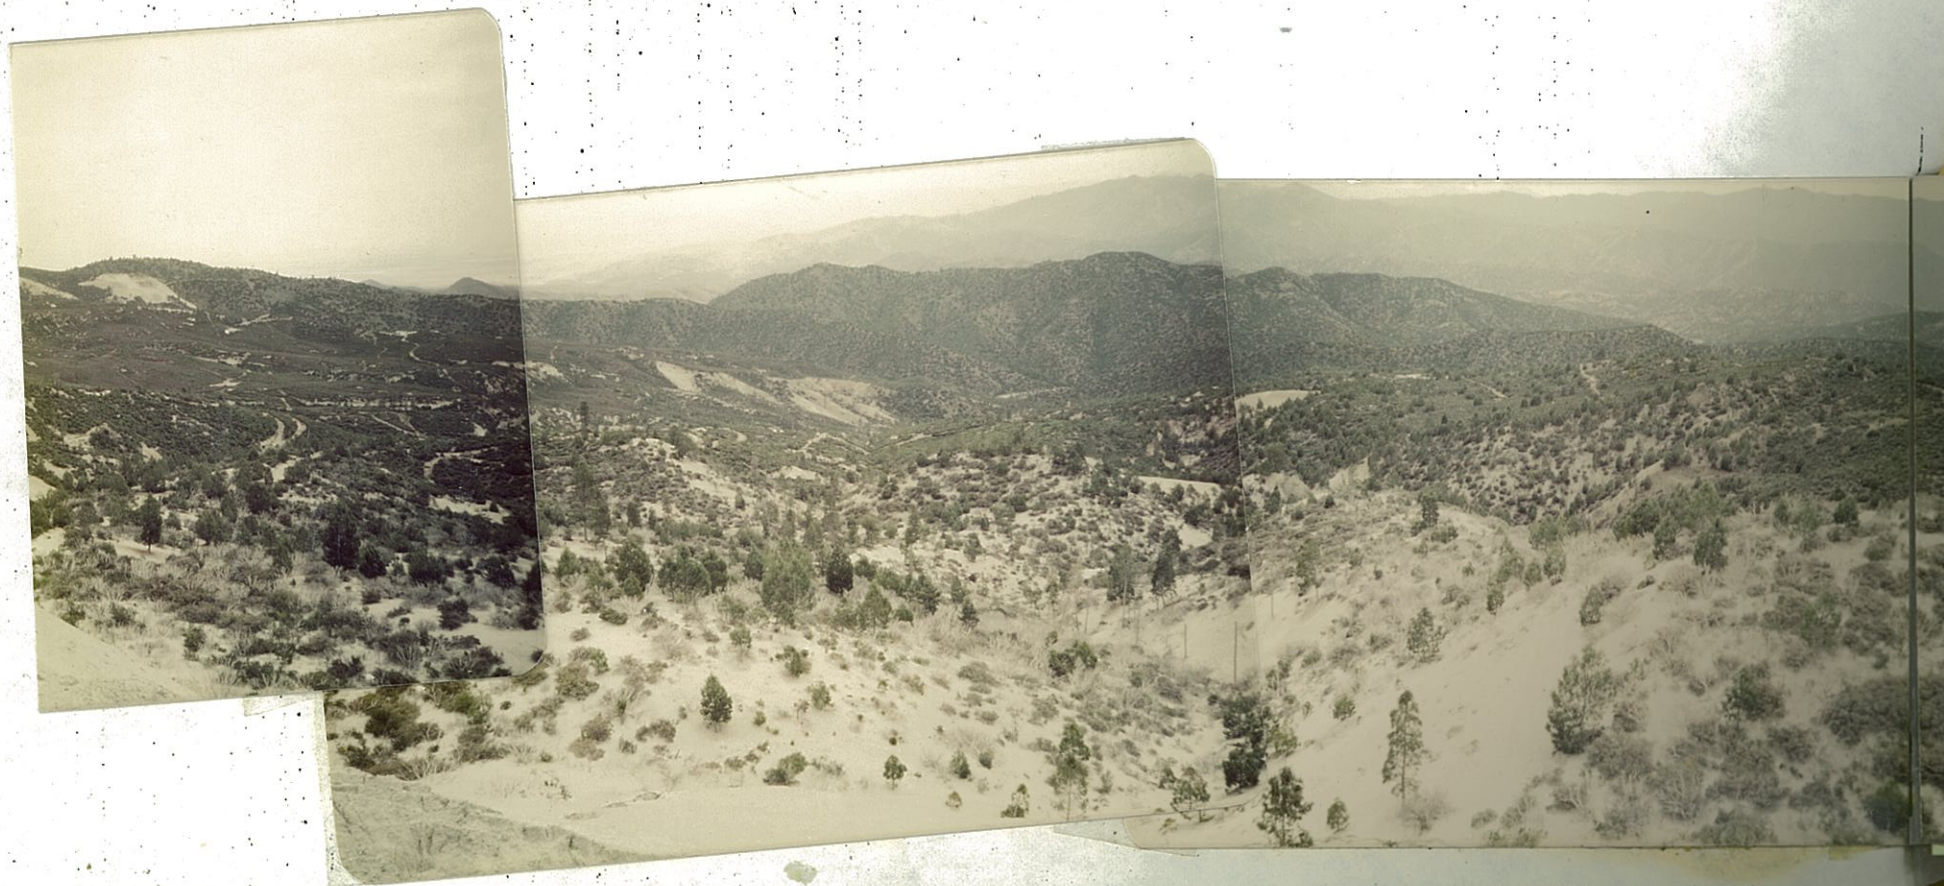
No. A23, A24, A25, A26, A27

Photos A 23 through A 27 give a panoramic view from the southern edge of the top of the tailings pile (looking south.) The main feature in this panorama is the lower "bench" adjacent to the tailing pile. This "bench" is approximately 75 feet lower than the top of the tailings pile. It is unclear whether this bench is an older portion of the tailings pile or whether tailings material had been deposited over the terrain with the passage of time, by wind and runoff. During periods of heavy precipitation runoff from the tailings pile flows onto this bench and then continues via an unnamed tributary stream to White Creek.

Subject: This picture was taken from the south edge of the top
of the tailings pile, facing south.

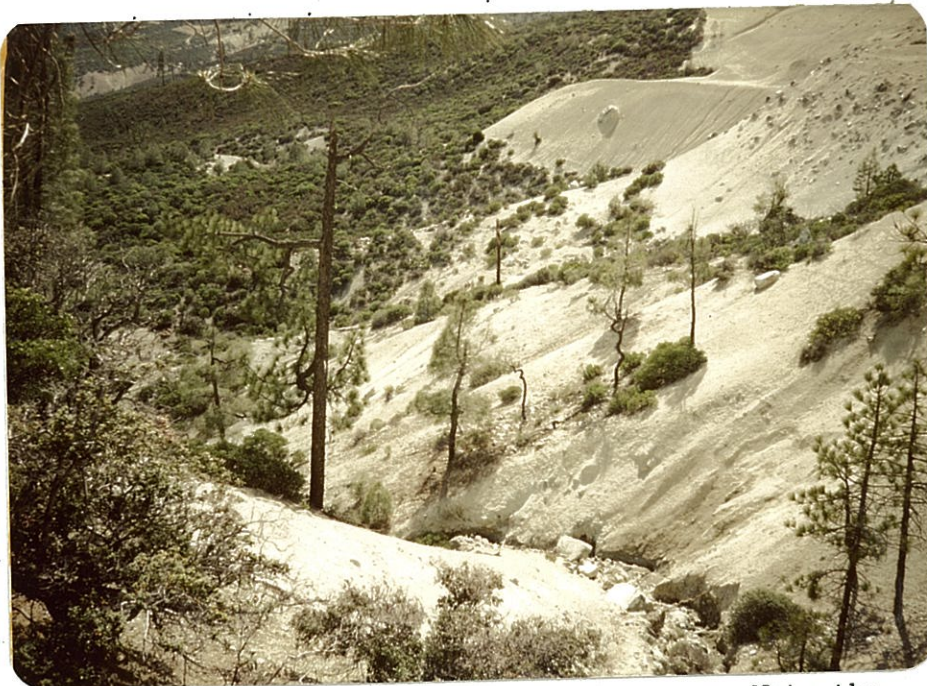
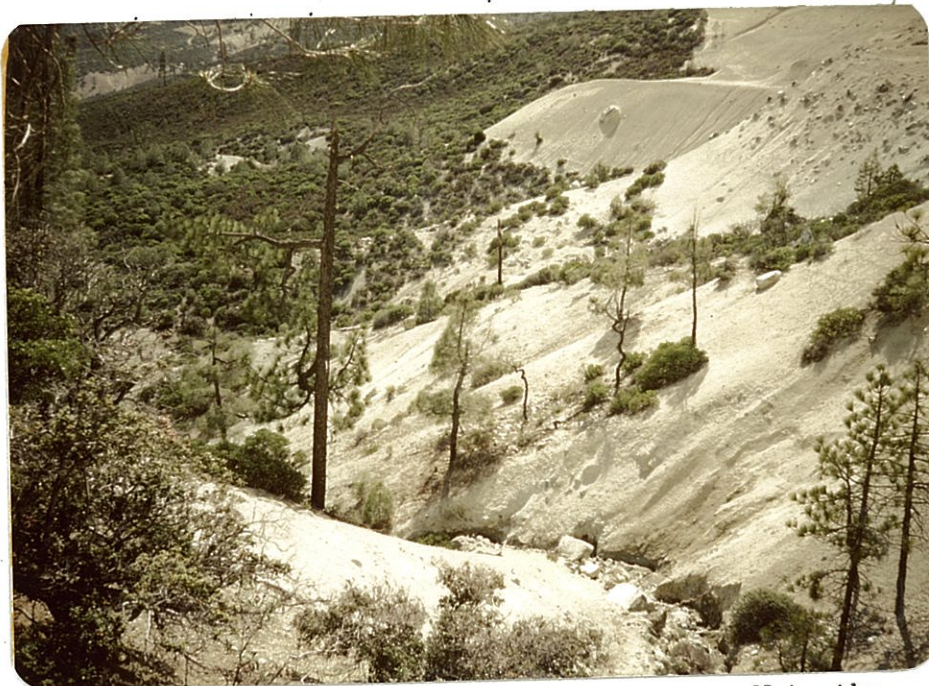
No. A28 Subject: Atlas Asbestos Mining Area. Note the drainage pattern

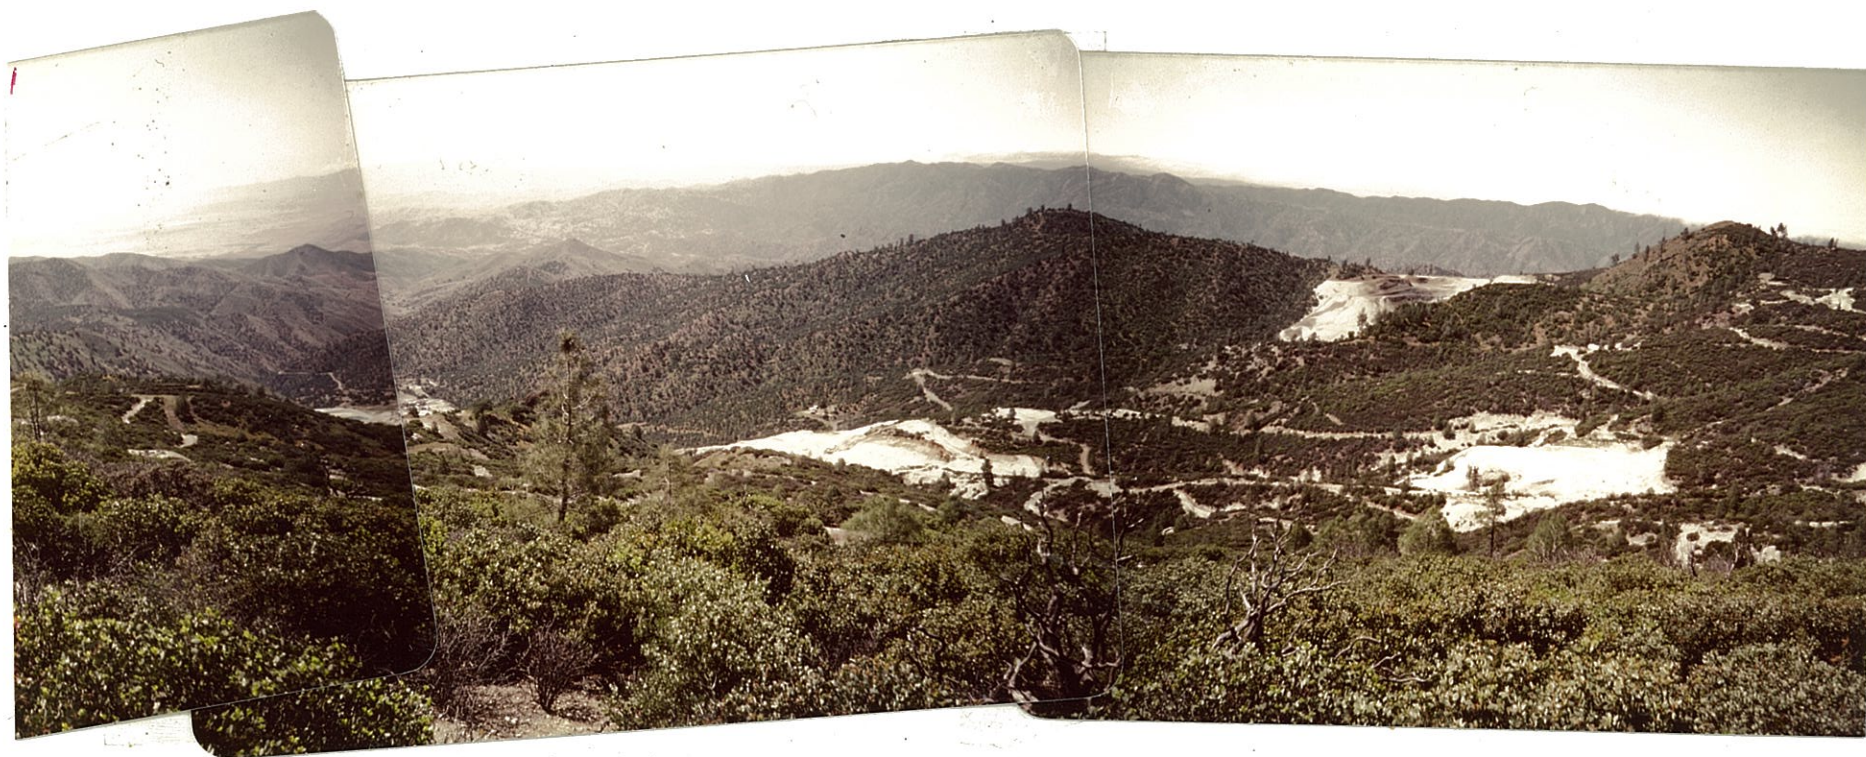
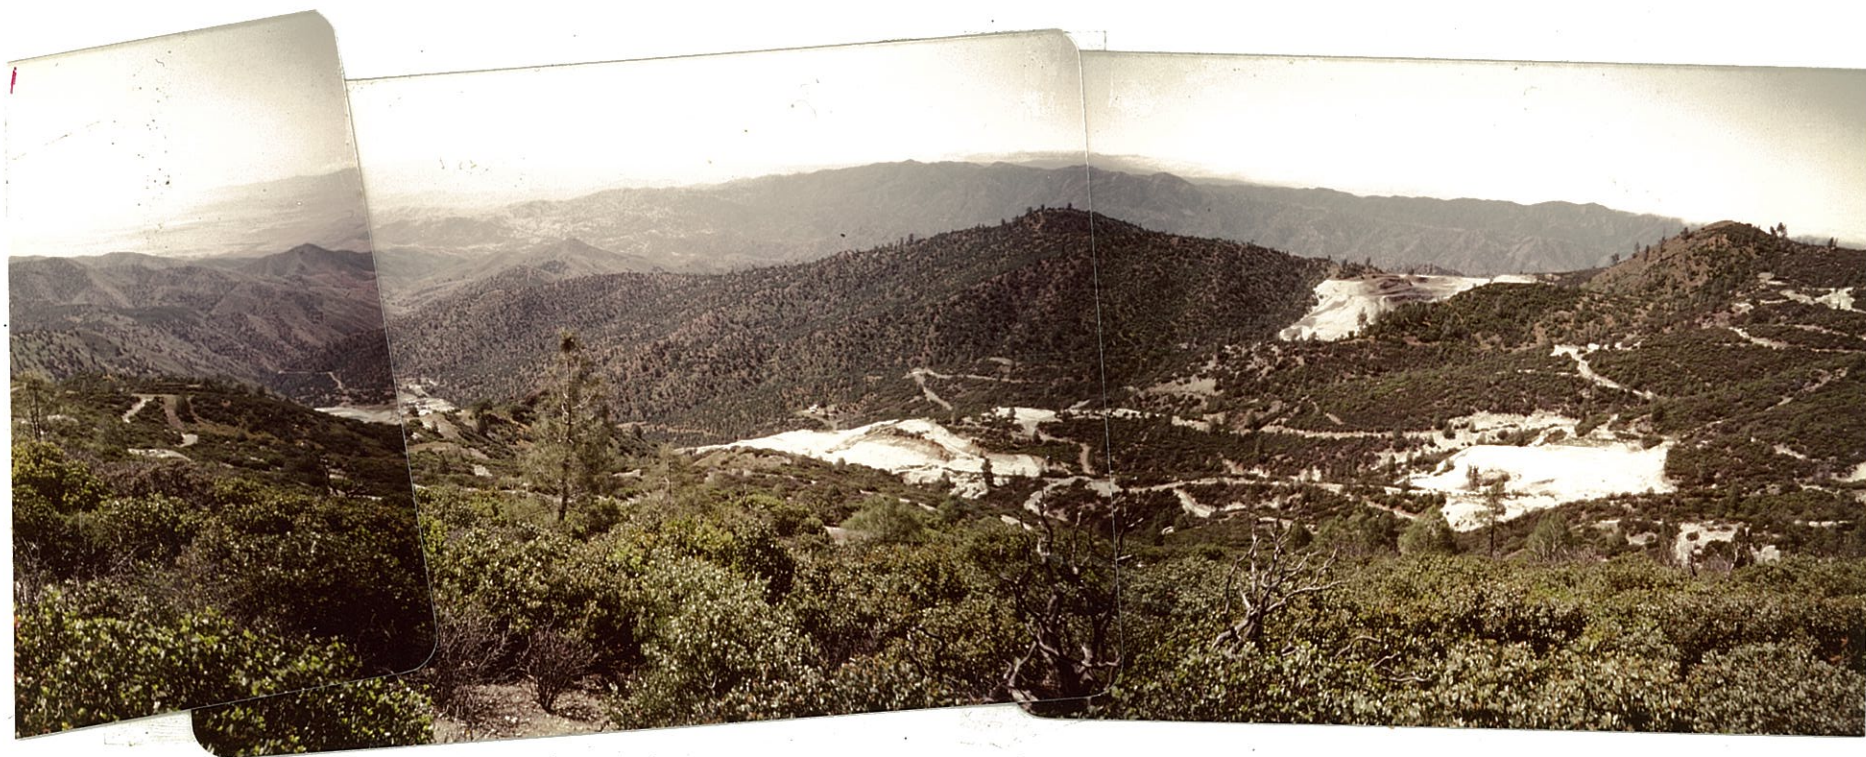
No. C1, C2, C3

Much of the mining site is devoid of vegetation (See photos C 1 through C 7.) During periods of heavy precipitation and runoff this area is subject to extensive erosion as is indicated in the photos of the mining area. Runoff from the mining area reaches Los Gatos Creek via Pine Canyon Creek.

Subject: A panoramic view of the Coalinga mining area.

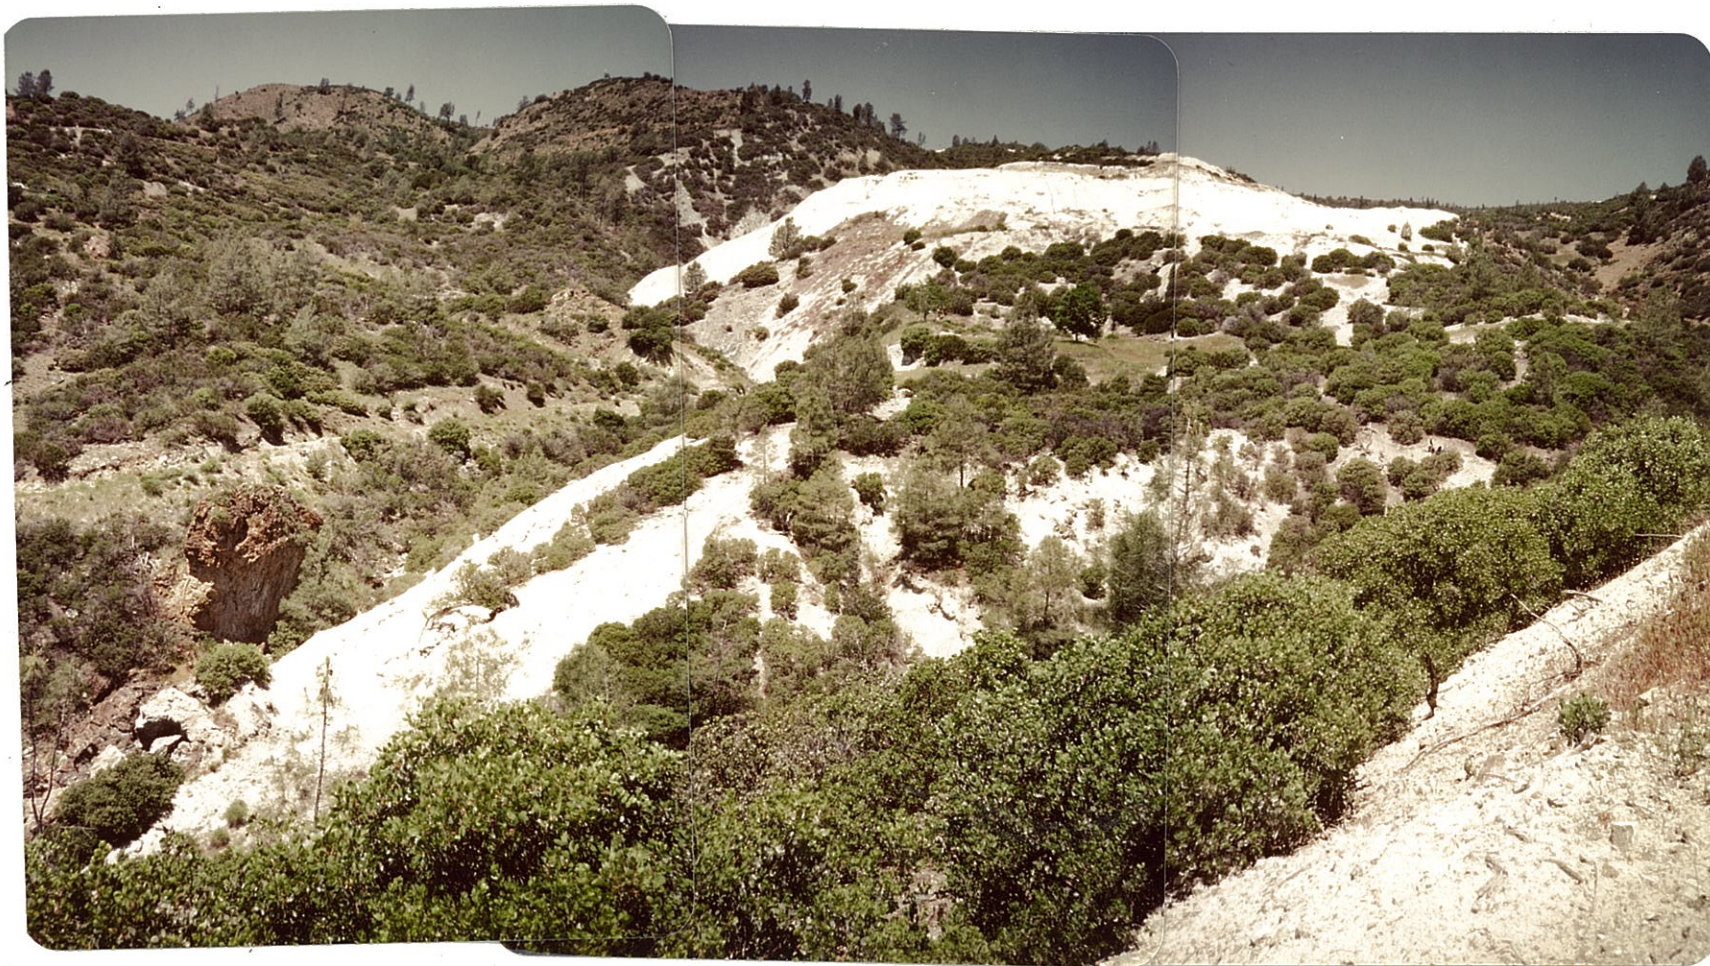
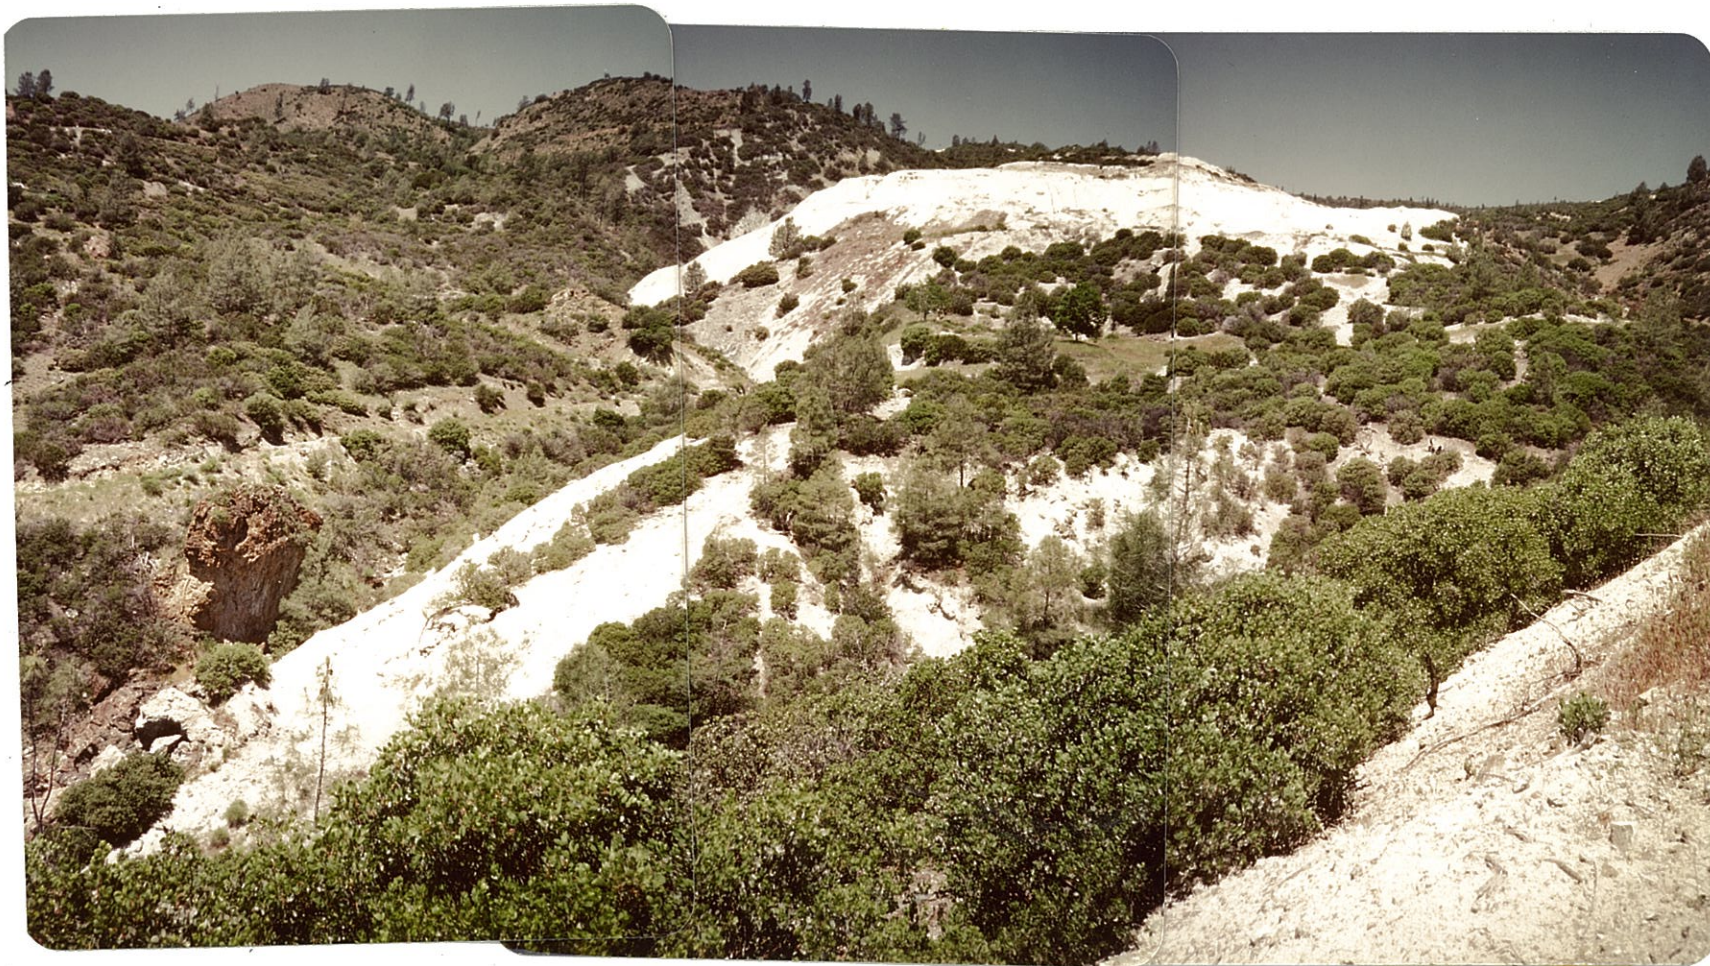
No. C5, C6, C7

Subject: Mining area of the Coalinga Mine.

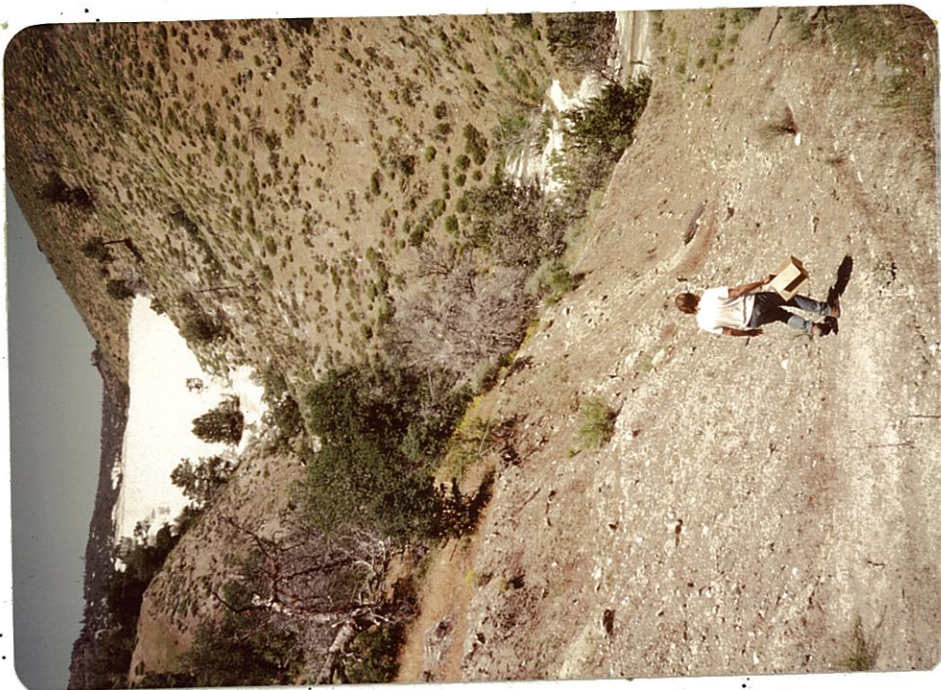
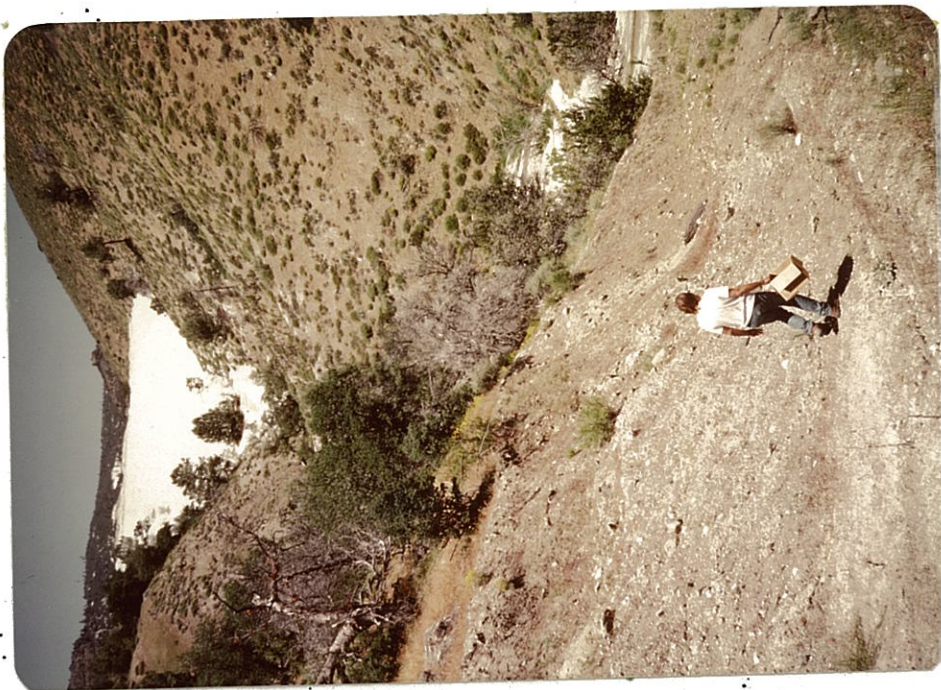
The tailings pile was estimated from field observations to be approximately 5 to 10 acres in area. Analysis of field samples (see Sampling section) indicated the tailings pile is 10% (by weight) chrysolite, a fibrous asbestos mineral. Photos C 8 through C 12 provide different views of the tailings pile. The tailings pile is located in a small canyon (see photo C 8.)

No. C8 Subject: A view of the face of the Coalinga
tailings pile

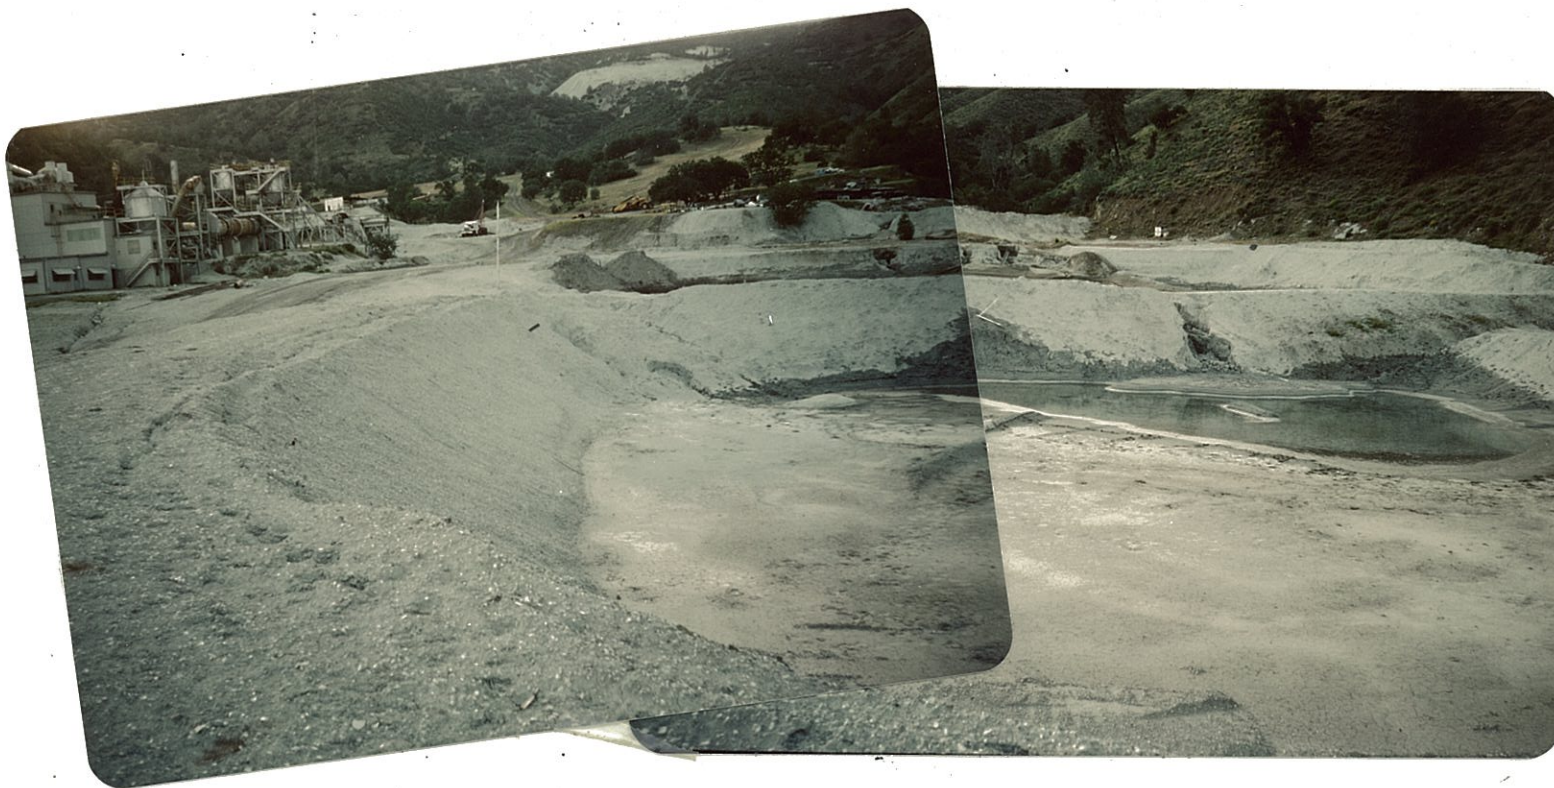
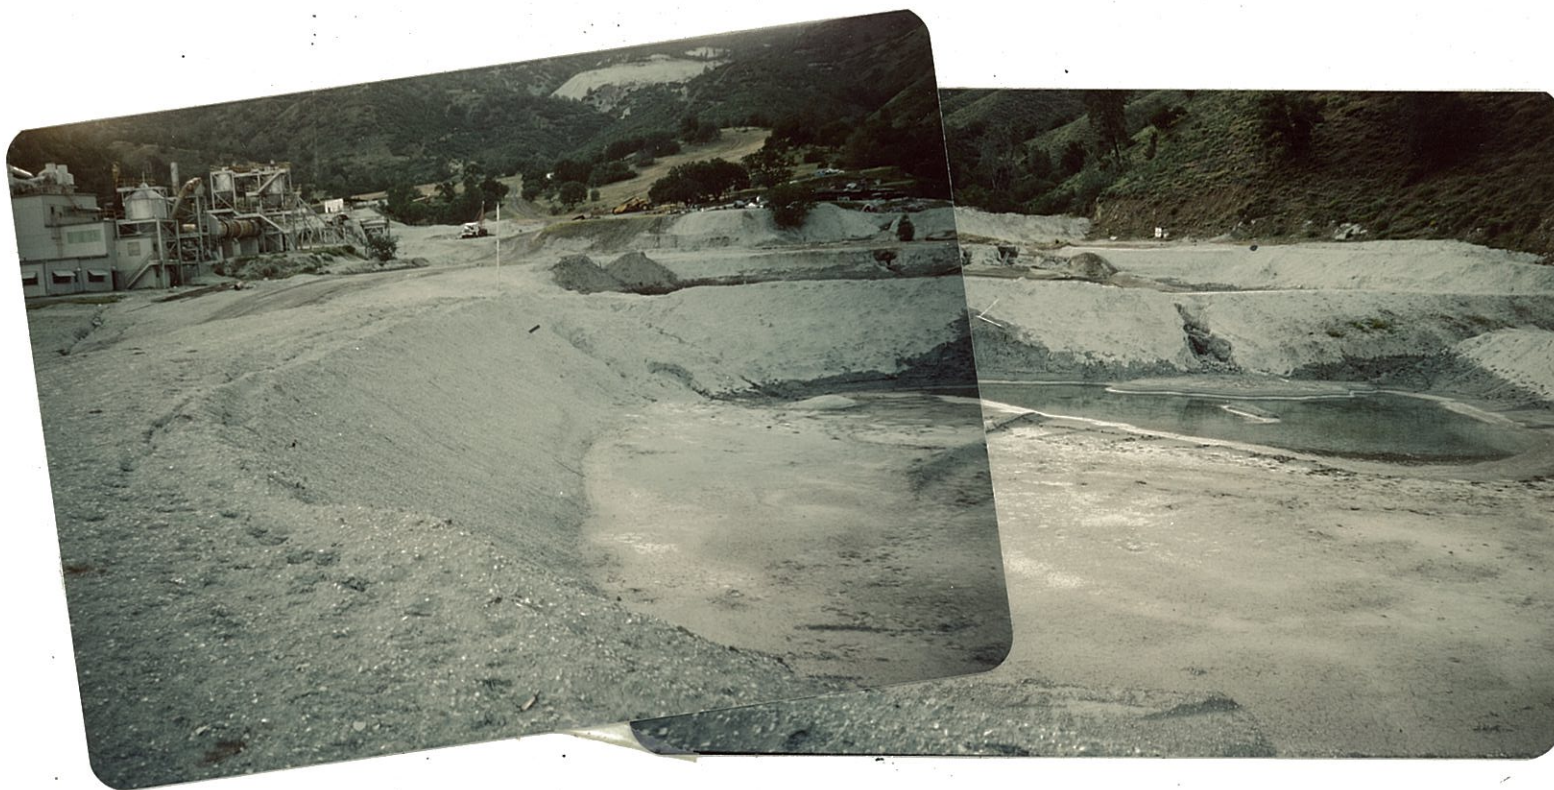
No. C10, C11

Subject: The top of the Coalinga tailings pile. Note
the series of erosion control dams.
